Re: Monthly Report Summary #19 for the South Orange County Reliability Enhancement (SOCRE) Project

South Orange County Reliability Enhancement Project CPUC Site Inspection Form

Project:	South Orange County Reliability Enhancement (SOCRE) Project	Date:	May 7, 2019
Project Proponent:	San Diego Gas & Electric (SDG&E)	Report #:	VS032
Lead Agency:	California Public Utilities Commission (CPUC)	Monitor(s):	CPUC/Ecology and Environment (E & E) Compliance Monitor
CPUC PM:	Andrew Barnsdale, Energy Division	AM/PM Weather:	Overcast with slight drizzle, cool and breezy
CPUC CM (E & E):	Joe Donaldson	Start/End Time:	0730 to 0830
Project NTP(s):	NTP-1, NTP-2, NTP-2 Addendum 1, NTP-3, and NTP-4

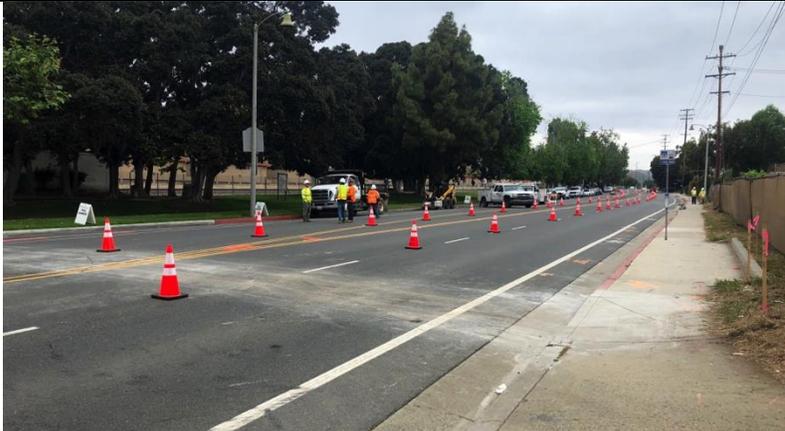
Photo 1 – Work occurring within Camino Capistrano. Photo facing north.
5/15/19	San Juan Capistrano Substation

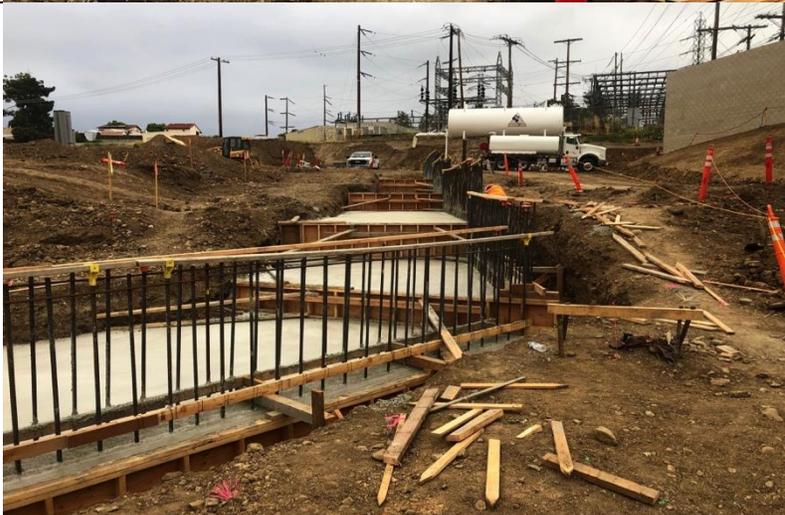
Photo 3 – Southern edge of the concrete retaining wall foundation. Photo facing east.

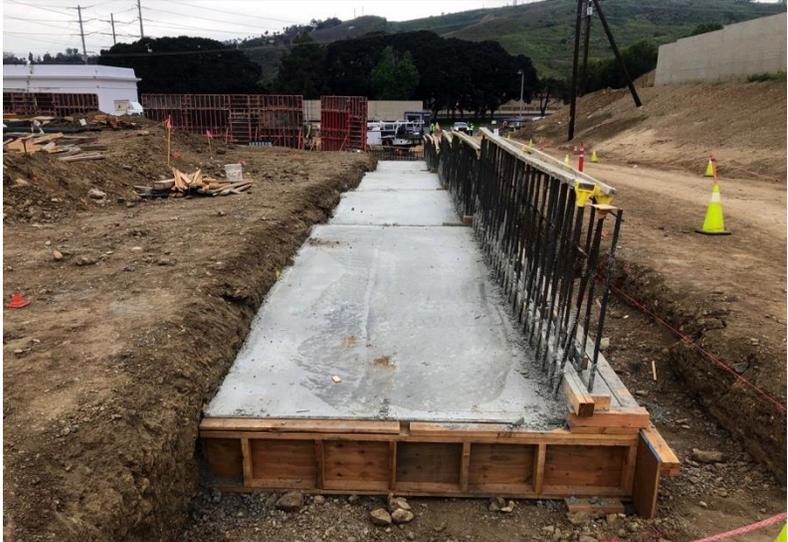
Photo 4 – Northern edge of the concrete retaining wall foundation. Photo facing west.
5/15/19	San Juan Capistrano Substation

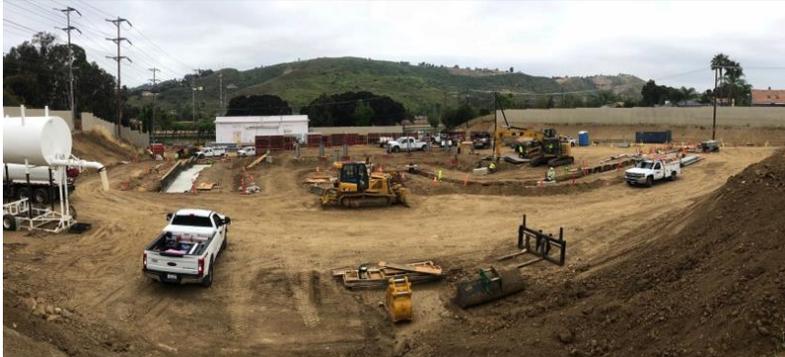
Photo 8 – Overview of the San Juan Capistrano Substation site looking west from the construction trailers.
5/15/19	San Juan Capistrano Substation

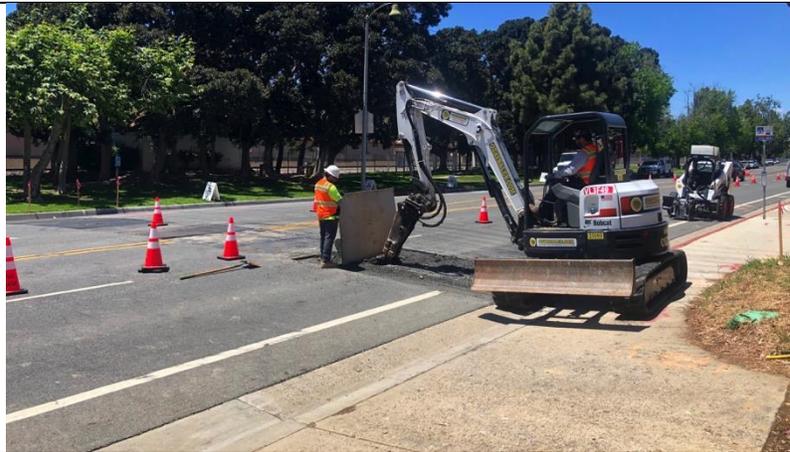
I arrived onsite at 1200. The SDG&E Environmental Coordinator was onsite at Camino Capistrano and spoke with the contractor who was completing the work within Camino Capistrano. About half of the asphalt had been removed from over the trench and steel plates had been put in place to allow vehicle passage. A backhoe with a breaker bar was completing trenching activities and removing the remaining asphalt as well as concrete that was under the asphalt (Photo 1). The Cultural Resource Monitor and Archaeological Resource Monitor were onsite for the Camino Capistrano work in the event that the contractor began digging below street level. The SDG&E Environmental Coordinator said that the Paleontological Resource Monitor would be onsite for the Camino Capistrano work once the trench is deeper. Equipment that would be used for the work within Camino Capistrano was staged at the southern entrance of the San Juan Capistrano Substation site (Photo 3). An additional SDG&E representative was also onsite and checking on the work within Camino Capistrano.

Photo 1 – Trenching occurring within Camino Capistrano. Photo facing north.
5/20/19	San Juan Capistrano Substation

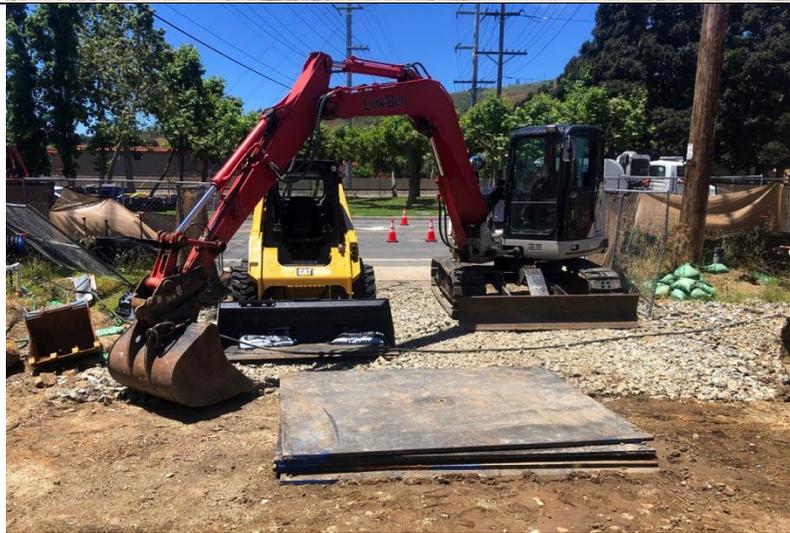
Photo 3 – Equipment to be used for the work within Camino Capistrano staged at the San Juan Capistrano Substation site's southern entrance. Photo facing west.

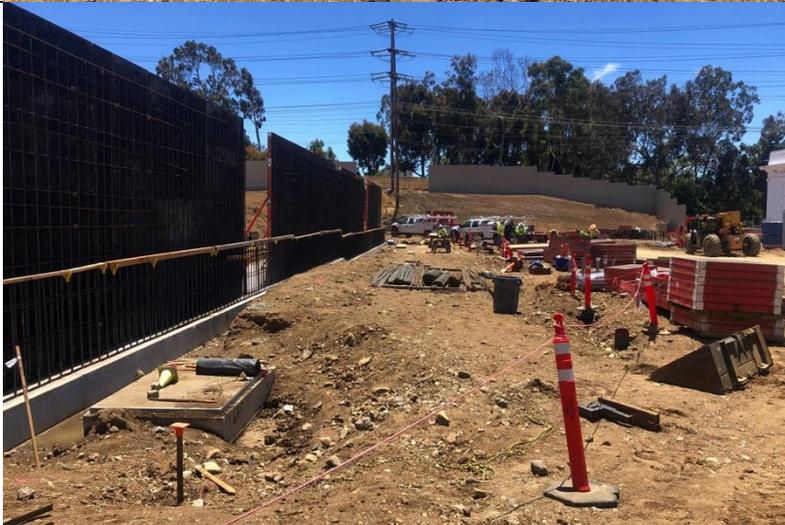
Work was being conducted for the installation of the steel forms for the western edge of the building pad retaining wall (Photo 5). The SDG&E Environmental Coordinator said they anticipated pouring concrete for the steel forms soon. Once the steel forms are installed, stockpiled soil will be used for backfill behind the forms (Photo 11).

Photo 5 – Form installation continues for the western portion of the retaining wall. Photo facing south.
5/20/19	San Juan Capistrano Substation

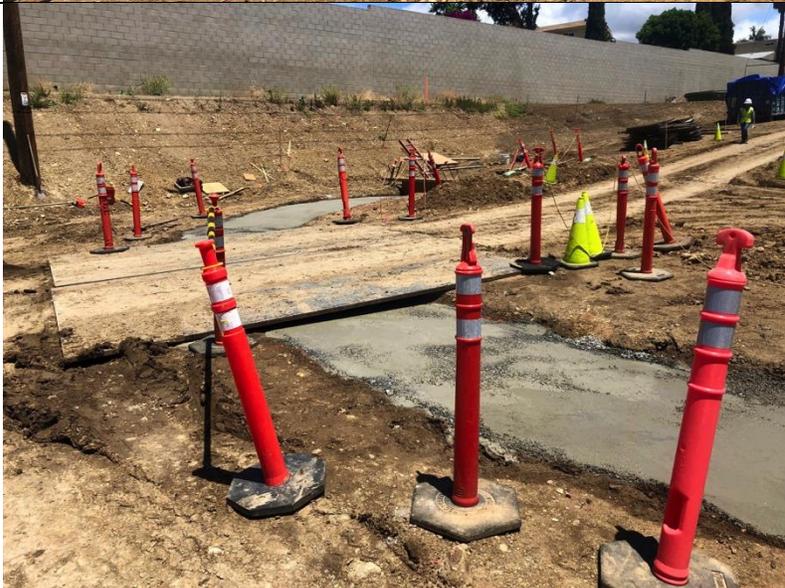
Conduit installation was being conducted within the 138-kilovolt (kV) gas-insulated substation (GIS) building pad, slurry was being poured (Photo 6), and conduit was being installed (Photo 7). Excavation and shoring of new conduit trench was also occurring (Photo 8). The SDG&E Environmental Coordinator explained that it was a special heat dissipating slurry, since the power transmission cables will generate high temperatures.

Photo 6 – Newly poured conduit trench. Photo facing northeast

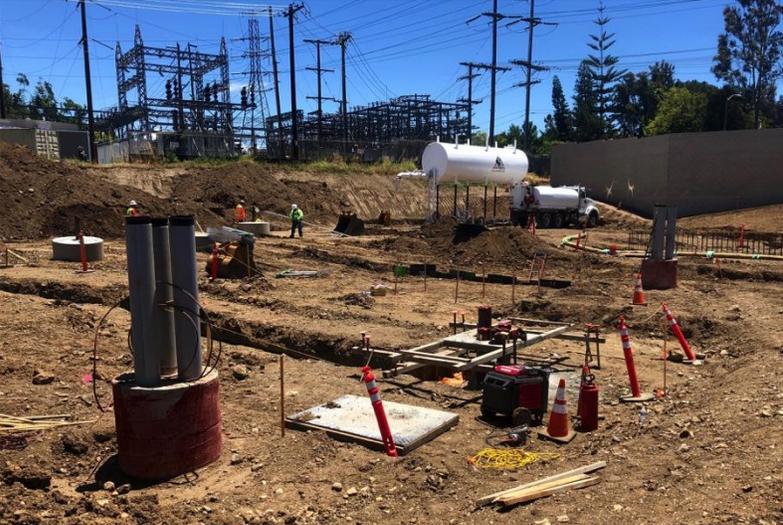
Photo 7 – Conduit installation within the 138 kV GIS building envelope. Photo facing southeast.
5/20/19	San Juan Capistrano Substation

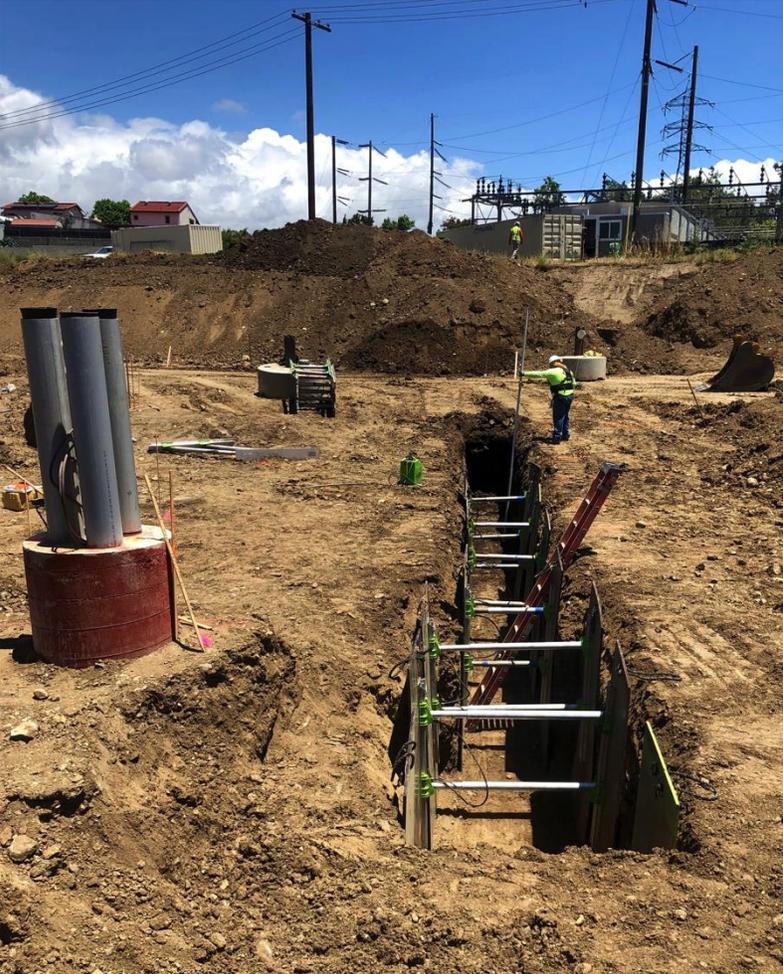
Photo 8 – Conduit trenching within the 138 kV GIS building envelope. Photo facing east.

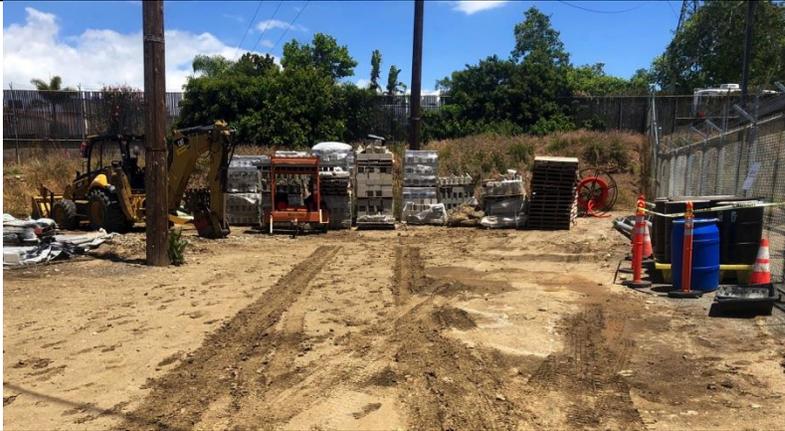
Photo 10 – Material staging area. Photo facing east.
5/20/19	San Juan Capistrano Substation

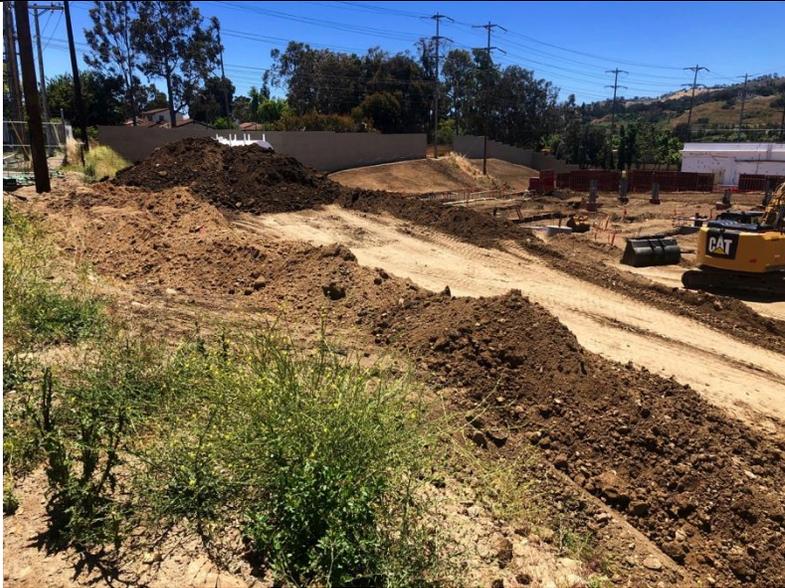
Photo 11 – Soil stockpile area. Photo facing southwest

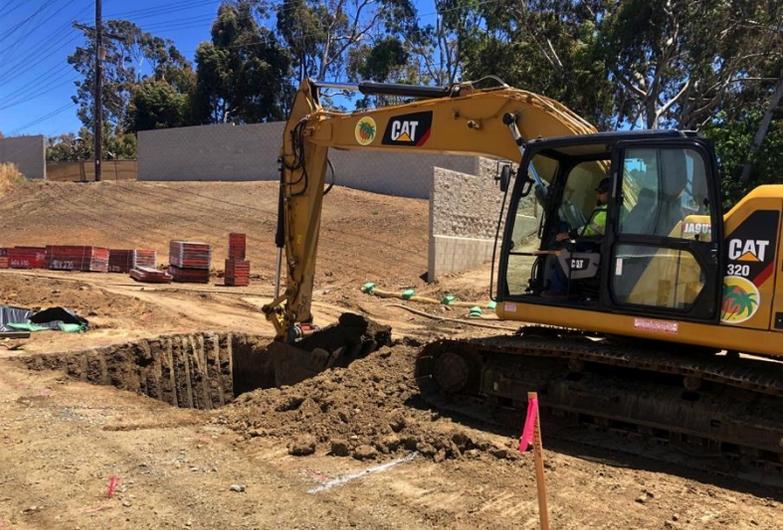
An crew was using an excavator to remove soil from the modular wetland system near the southern entrance of the San Juan Capistrano Substation site (Photo 13). Drainage from the San Juan Capistrano Substation site will enter the modular wetland system and then exit the San Juan Capistrano Substation site via the drainpipe being installed across the roadway.

Photo 13 – Excavator work at the modular wetland system site. Photo facing southeast.
5/20/19	San Juan Capistrano Substation

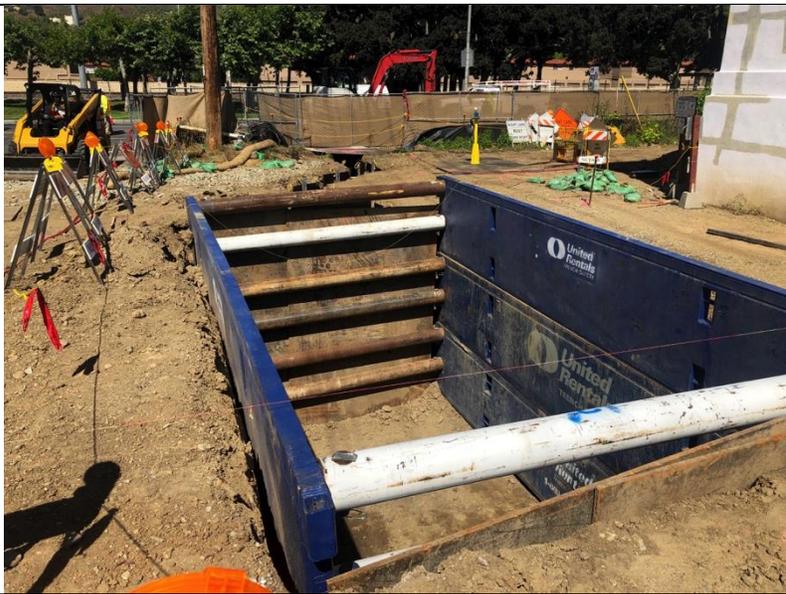
At the end of the day, I walked through the San Juan Capistrano Substation site with the E & E/CPUC Compliance Manager. Excavation activities were occurring near the southwest corner of the San Juan Capistrano Substation site, including shored trenches and a shored vault location (Photo 1). Work was being conducted on the 138 kilovolt (kV) gas-insulated substation (GIS) building pad retaining wall, including the installation of the steel forms (Photo 2).

Photo 1 – Excavation work connecting to trenching across Camino Capistrano. Photo facing west.
5/29/19	San Juan Capistrano Substation

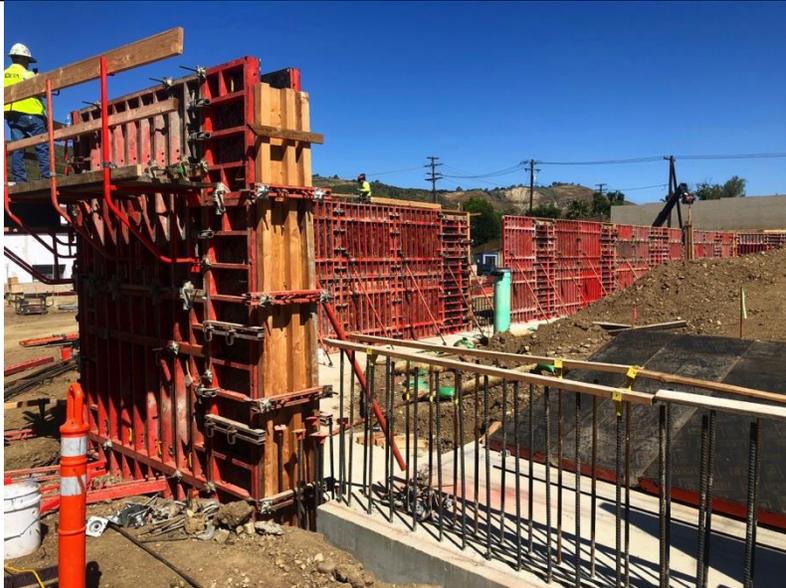
Photo 2 – Form installation for the retaining wall. Photo facing northwest.
5/29/19	San Juan Capistrano Substation

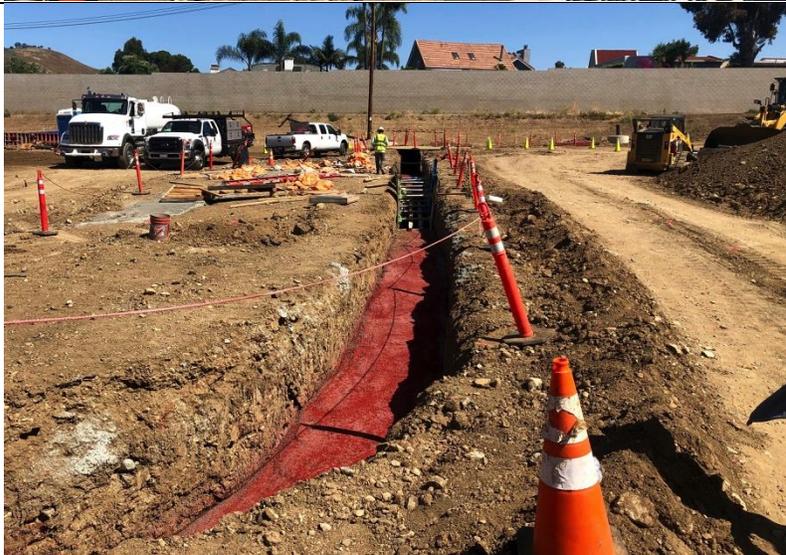
Conduit installation was also being conducted (Photo 3); the SDG&E Environmental Coordinator explained that the colored slurry serves an indicator/warning for anyone who may inadvertently dig around underground power lines (Photo 4).

Photo 3 – Conduit installation. Photo facing north.

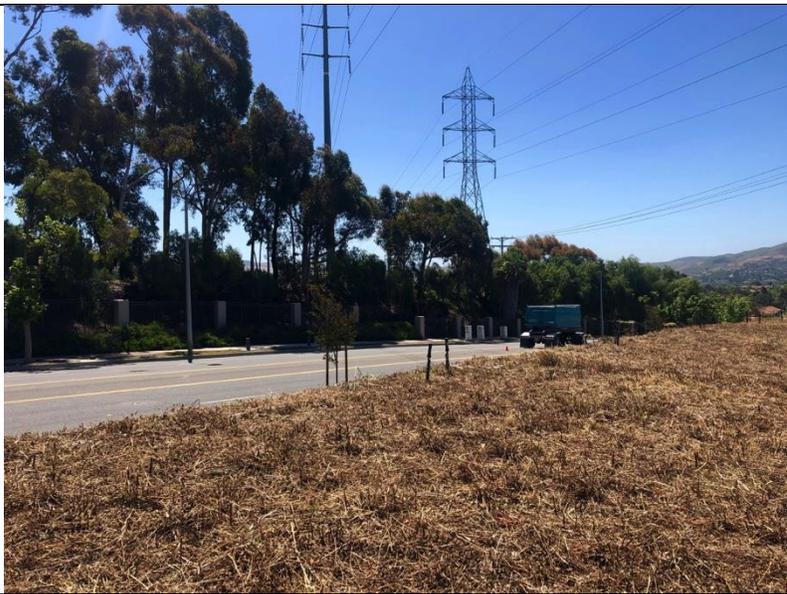
The site tour continued across Interstate 5 and stopped at the new distribution cable pole sites (4c and 2c) (Photo 4), and also stopped at TSP 5 (Photo 5). Additional locations that were visited during the site tour included TSPs 9, 14, 22, 34, 39, and 42.

<p>Photo 4 – New distribution cable pole sites 4c and 2c (photographed during the site tour and outside of the San Juan Capistrano Substation site). Photo facing southeast.</p>
5/29/19	SOCRE project transmission line

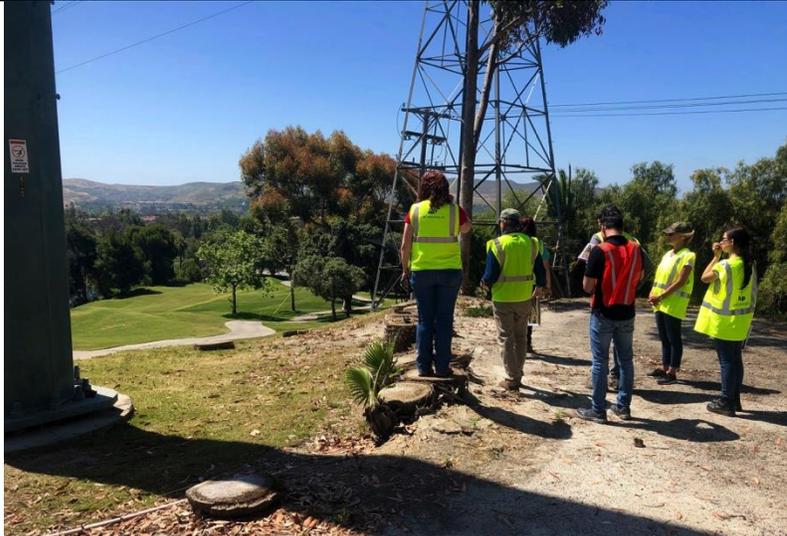
<p>Photo 5 – TSP 5 location overlooking the golf course (photographed during the site tour and outside of the San Juan Capistrano Substation site). Photo facing southeast.</p>
5/29/19	SOCRE project transmission line

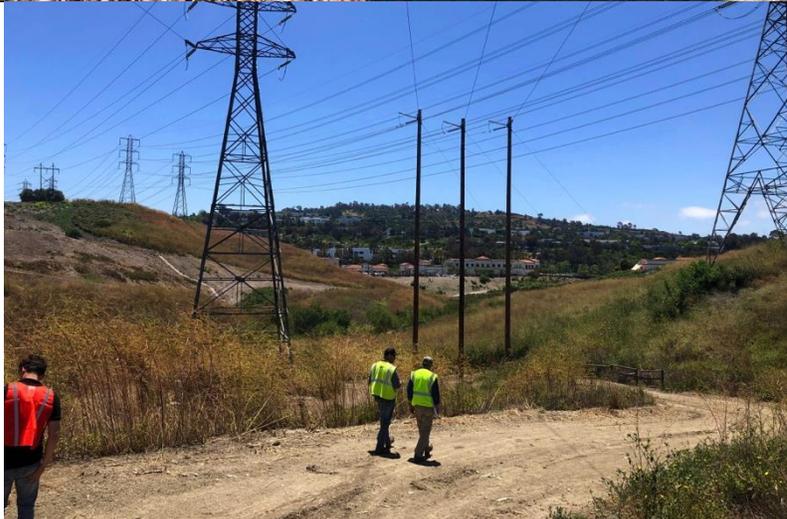
<p>Photo 6 – New transmission line location (photographed during the site tour and outside of the San Juan Capistrano Substation site). Photo facing south.</p>
